NAVAL AVIATION SAFETY CENTER

16. TIME IN FLIGHT 0		17. TYPE ACCIDENT S-1 RAN OFF END OF RUNWAY		18. PHASE OF FLIGHT 3-FLAPS UP TAKE OFF	
19. MODEL T2J-1		20. SERIAL NO. 118222		21. DAMAGE TO A/C <input checked="" type="checkbox"/> A <input type="checkbox"/> B <input type="checkbox"/> C <input type="checkbox"/> D <input type="checkbox"/> E <input type="checkbox"/> F

PART VI DAMAGE TO THE AIRCRAFT

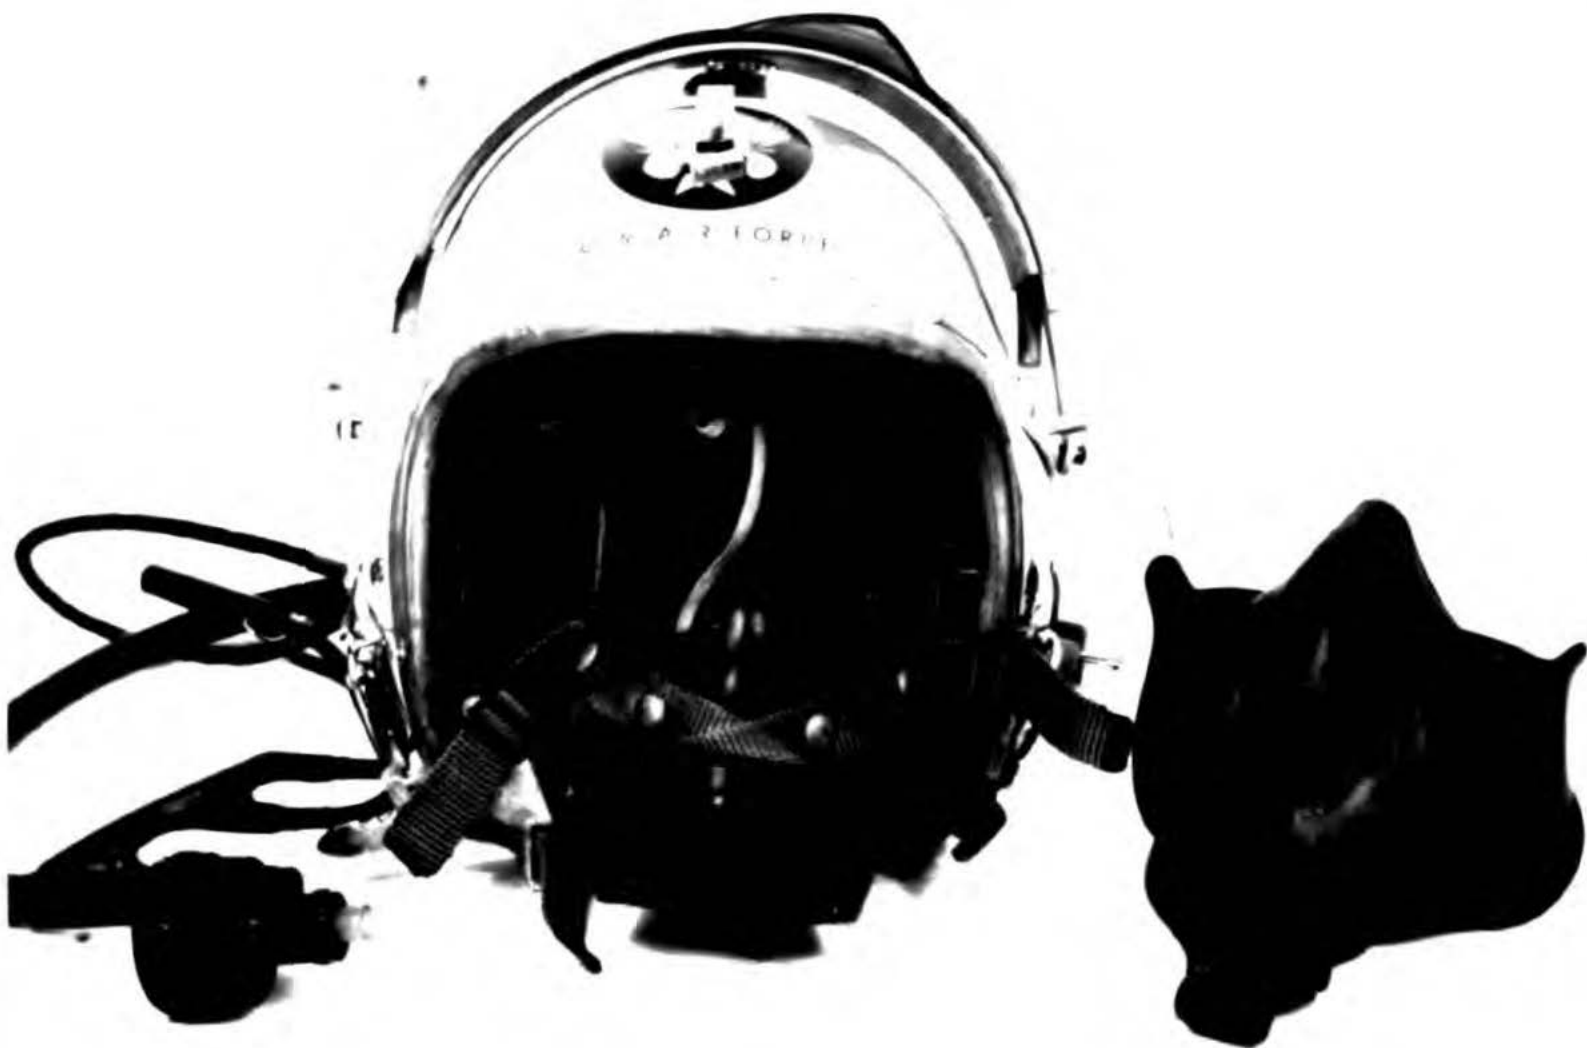
FOR 6-61 TRA 17 SAAS KINGSTILLE, TEXAS T2J-1 BU NO 148222. IMPACT DATA TO
SAFETY AND SURVIVAL EQUIPMENT UNIT: (b) (6)

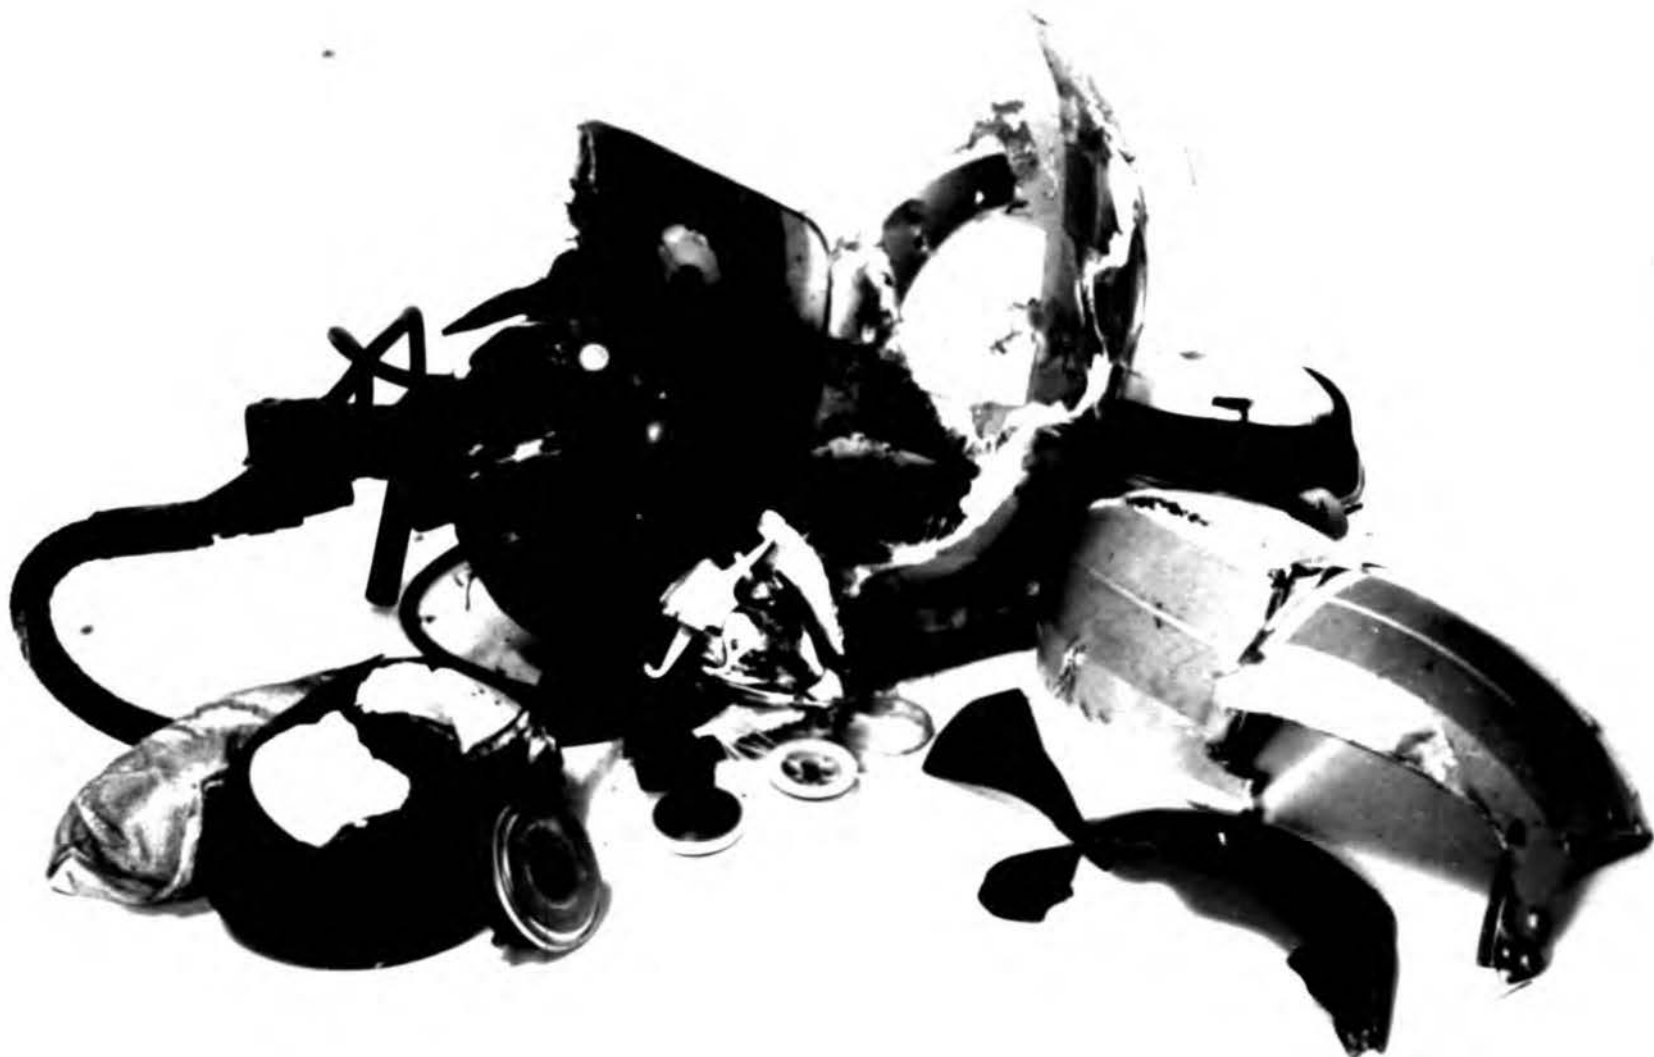
MOR 6-61 TRACON 7 ELLS KINGSVILLE, TEXAS. T2J-1 WNO 118222. IMPACT DATA E
TO SAFETY AND SURVIVAL EQUIPMENT. CO-PILOT: SECKINGER, J.V.

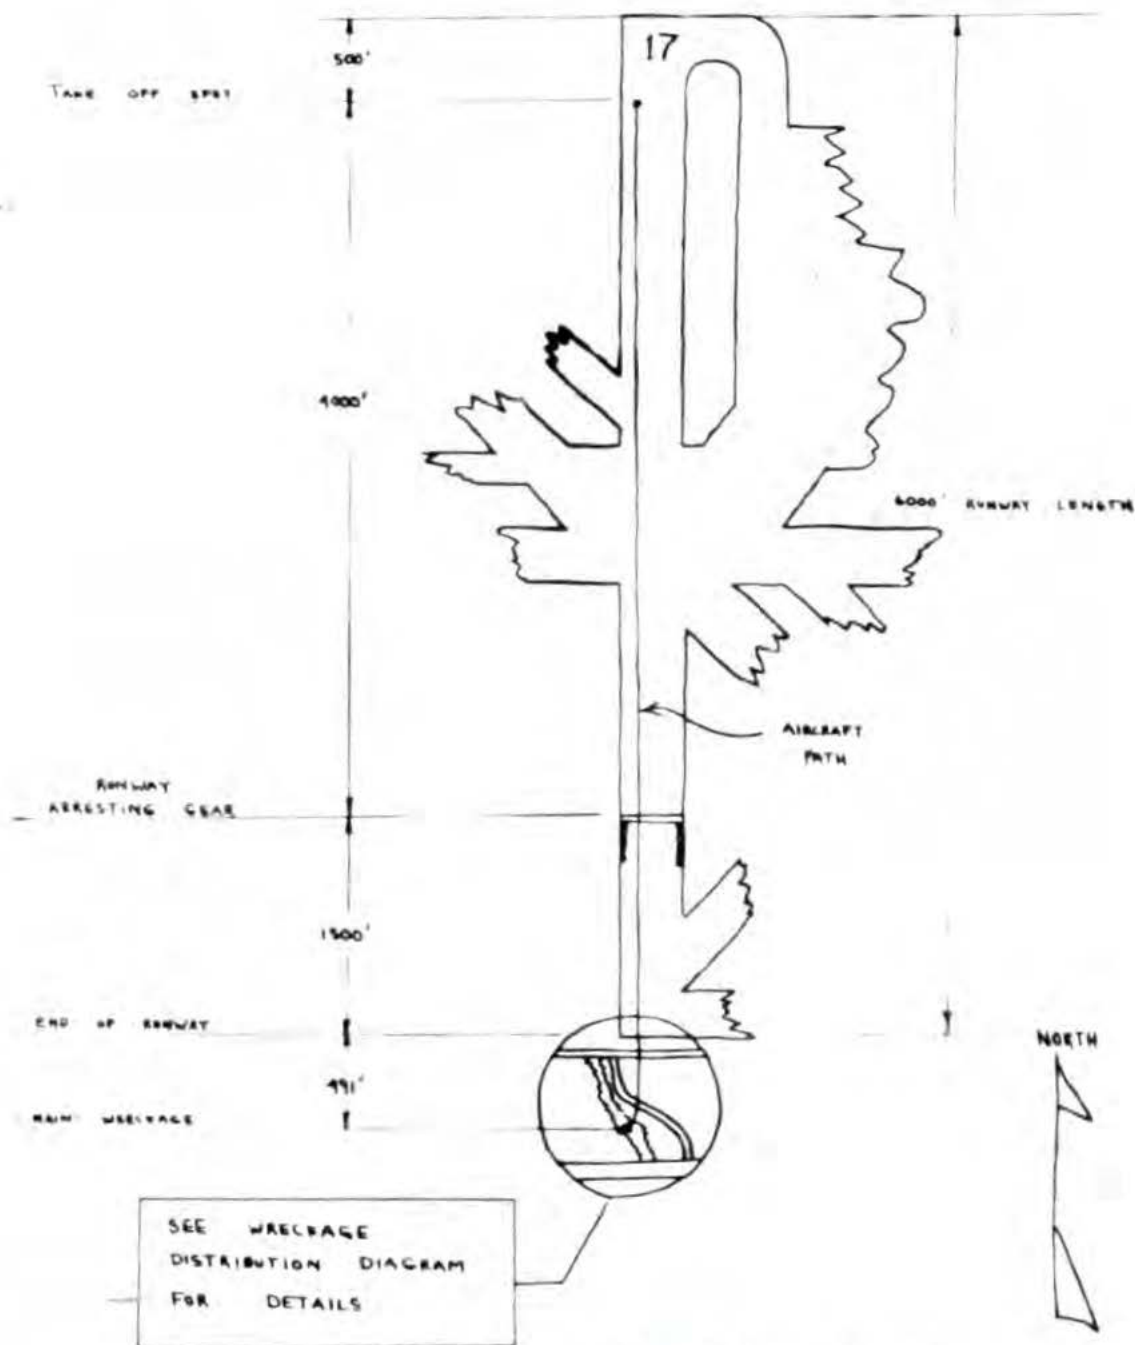
CONTINUING SA TRACON 7 RAR 6-61 T2J-1 BUWO 140222 P1147 (b) AIRCRAFT PATH: LAIRMAN
 FROM TAKE OFF SPOT TO PLACE WHERE WRECKAGE CAME TO A STOP. DRAWING IS TO SCALE. SPECIAL
 HANDLING REQUIRED IN ACCORDANCE WITH PARAGRAPH 70 OPNAVINST 3750.6D.

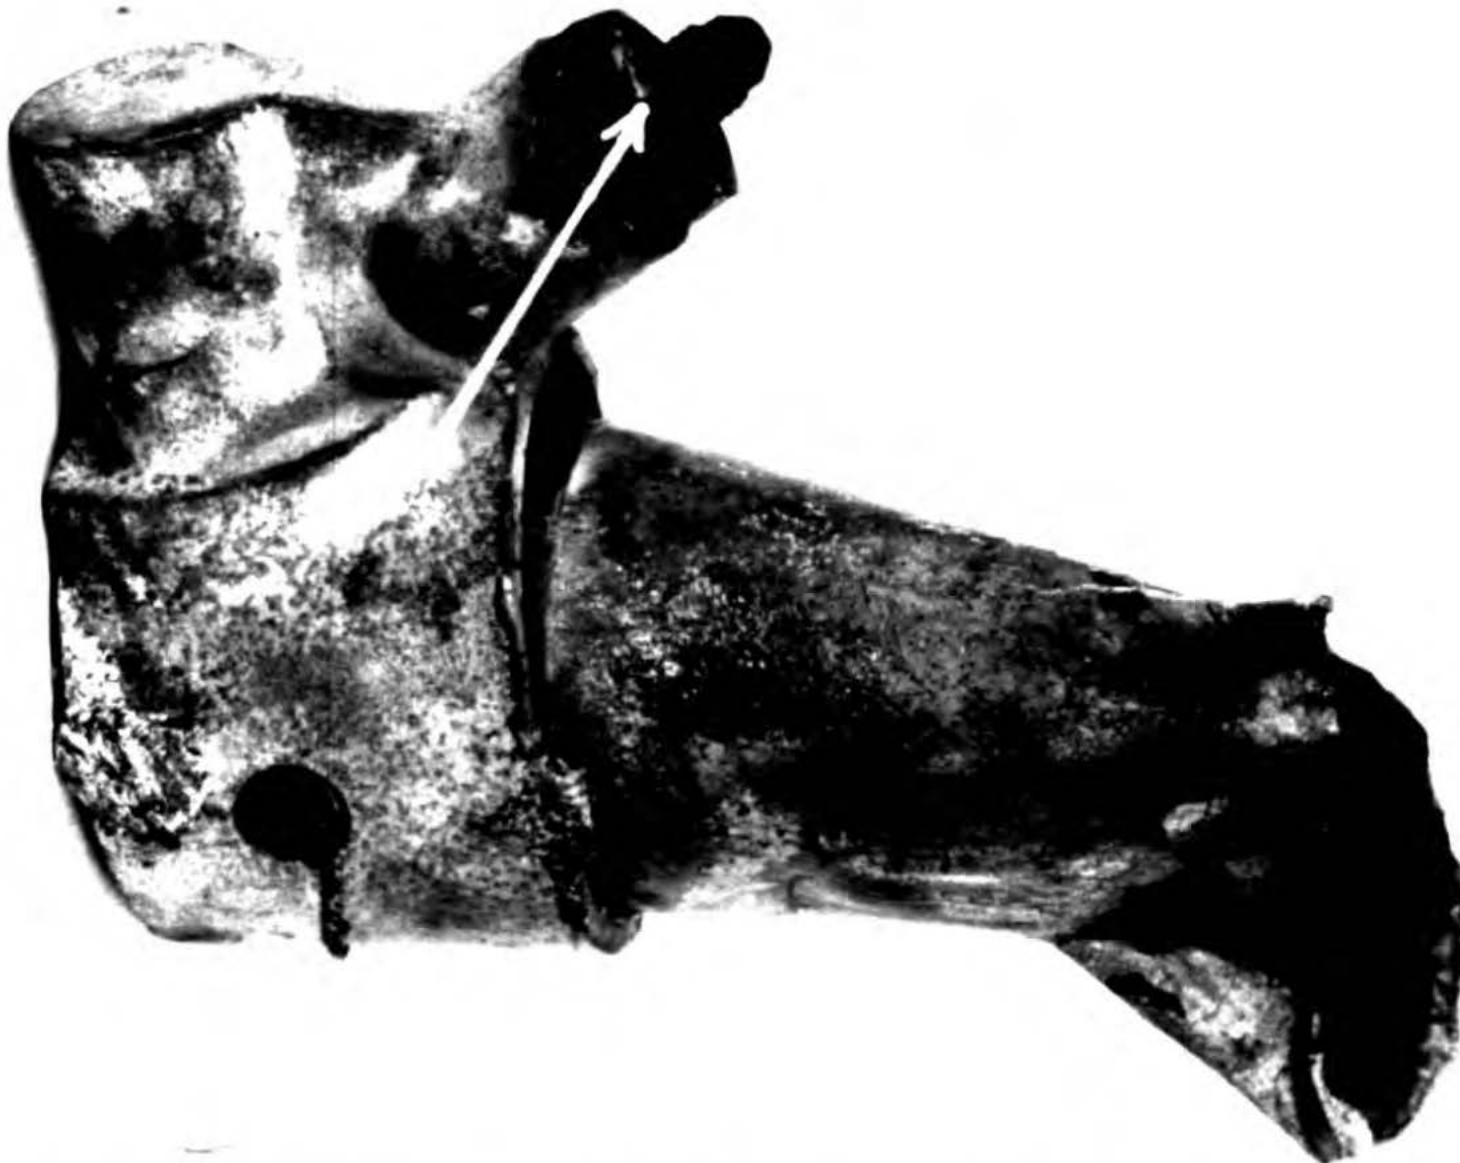
ENCLOSURE 6J TRARON 7 AAR 6-61 T2J-1 BUNO 118222 PILOT: (b)(6) VIEW OF
BOTTOM OF CANOPY ACTUATOR SHOWING THE THREADS OF GAS TUBE FITTING ON ACTU-
ATOR IN GOOD CONDITION. THIS INDICATES GAS TUBE WAS NOT CONNECTED TO THE
FITTING WHEN ACCIDENT OCCURRED. SPECIAL HANDLING REQUIRED IN ACCORDANCE
WITH PARAGRAPH 70 OPNAVINST 3750.6D.

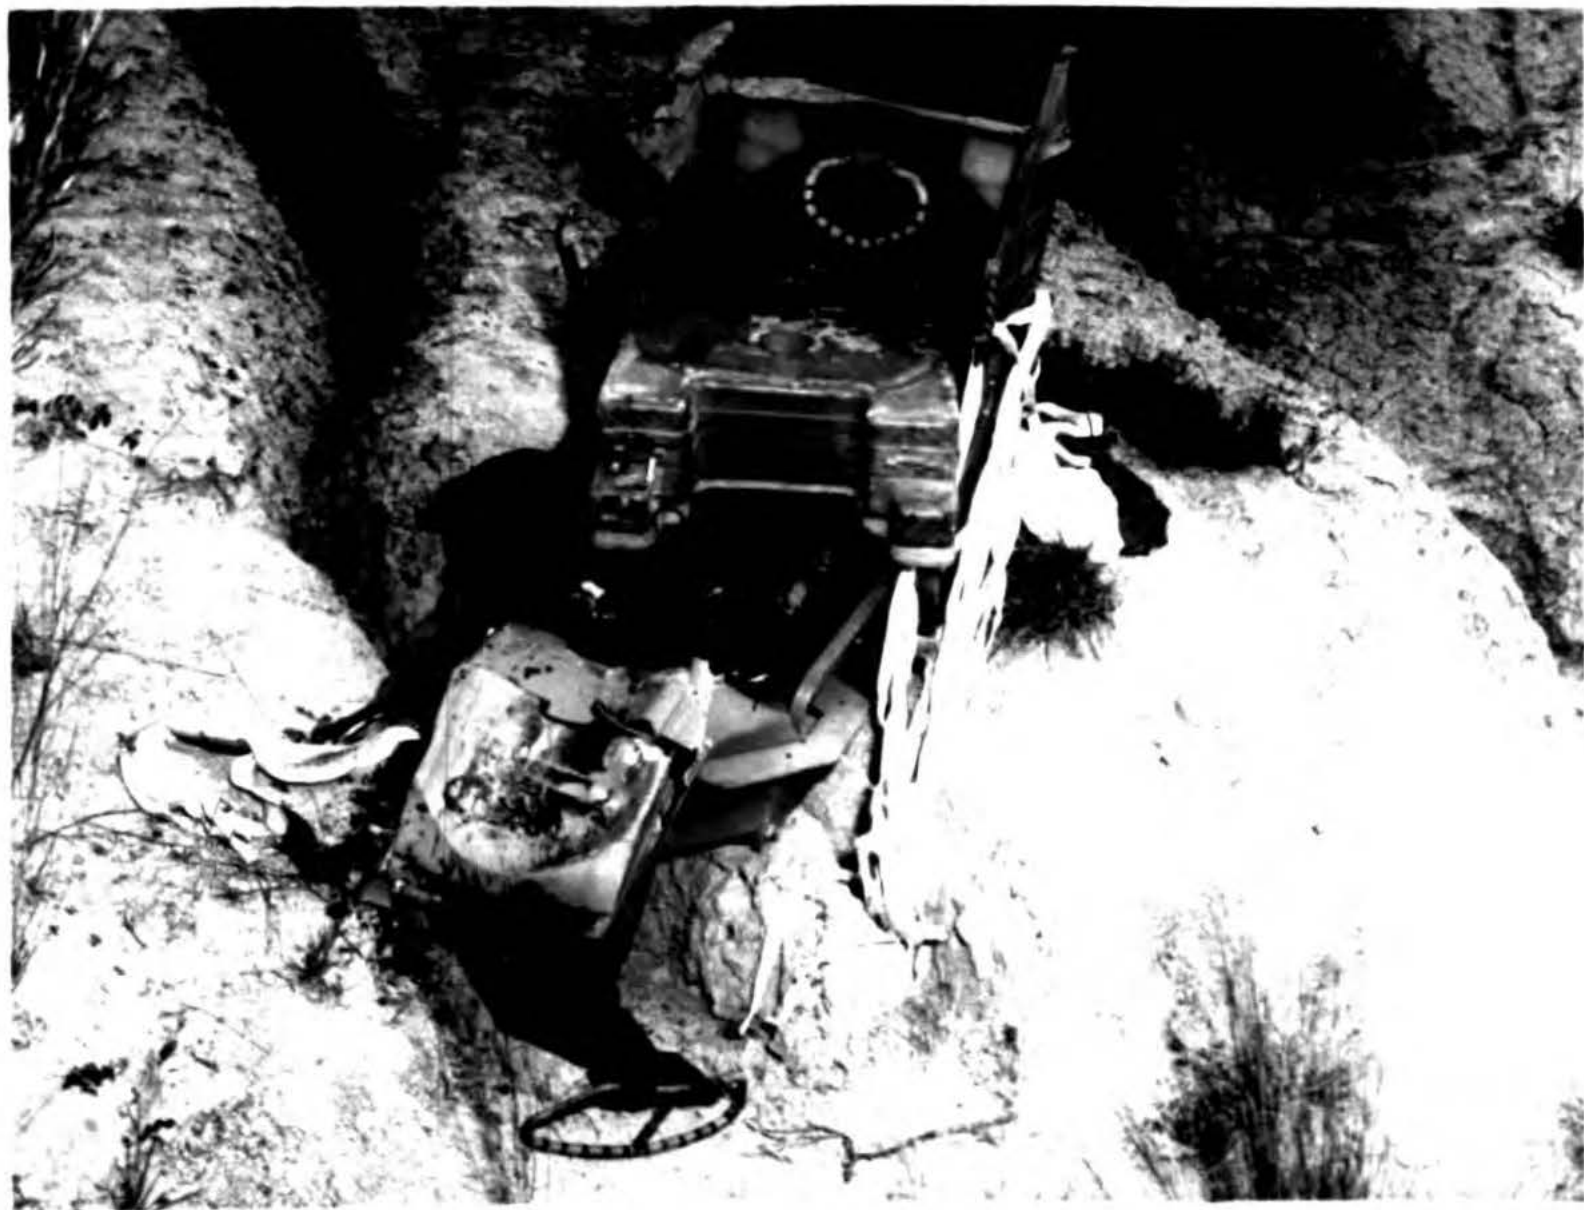
ENCLOSURE 6G TRARON 7 AAR 6-61 T2J-1 HUNG 118222. PILOT: (b) (6). WHERE
LCDR. SECKINGER AND SEAT CAME TO REST. THIS WAS 25 FEET FROM WHERE CONTACT
WITH THE GROUND WAS MADE. SPECIAL HANDLING REQUIRED IN ACCORDANCE WITH PAR-
AGRAPH 70 OPNAVINST 3750.6D.

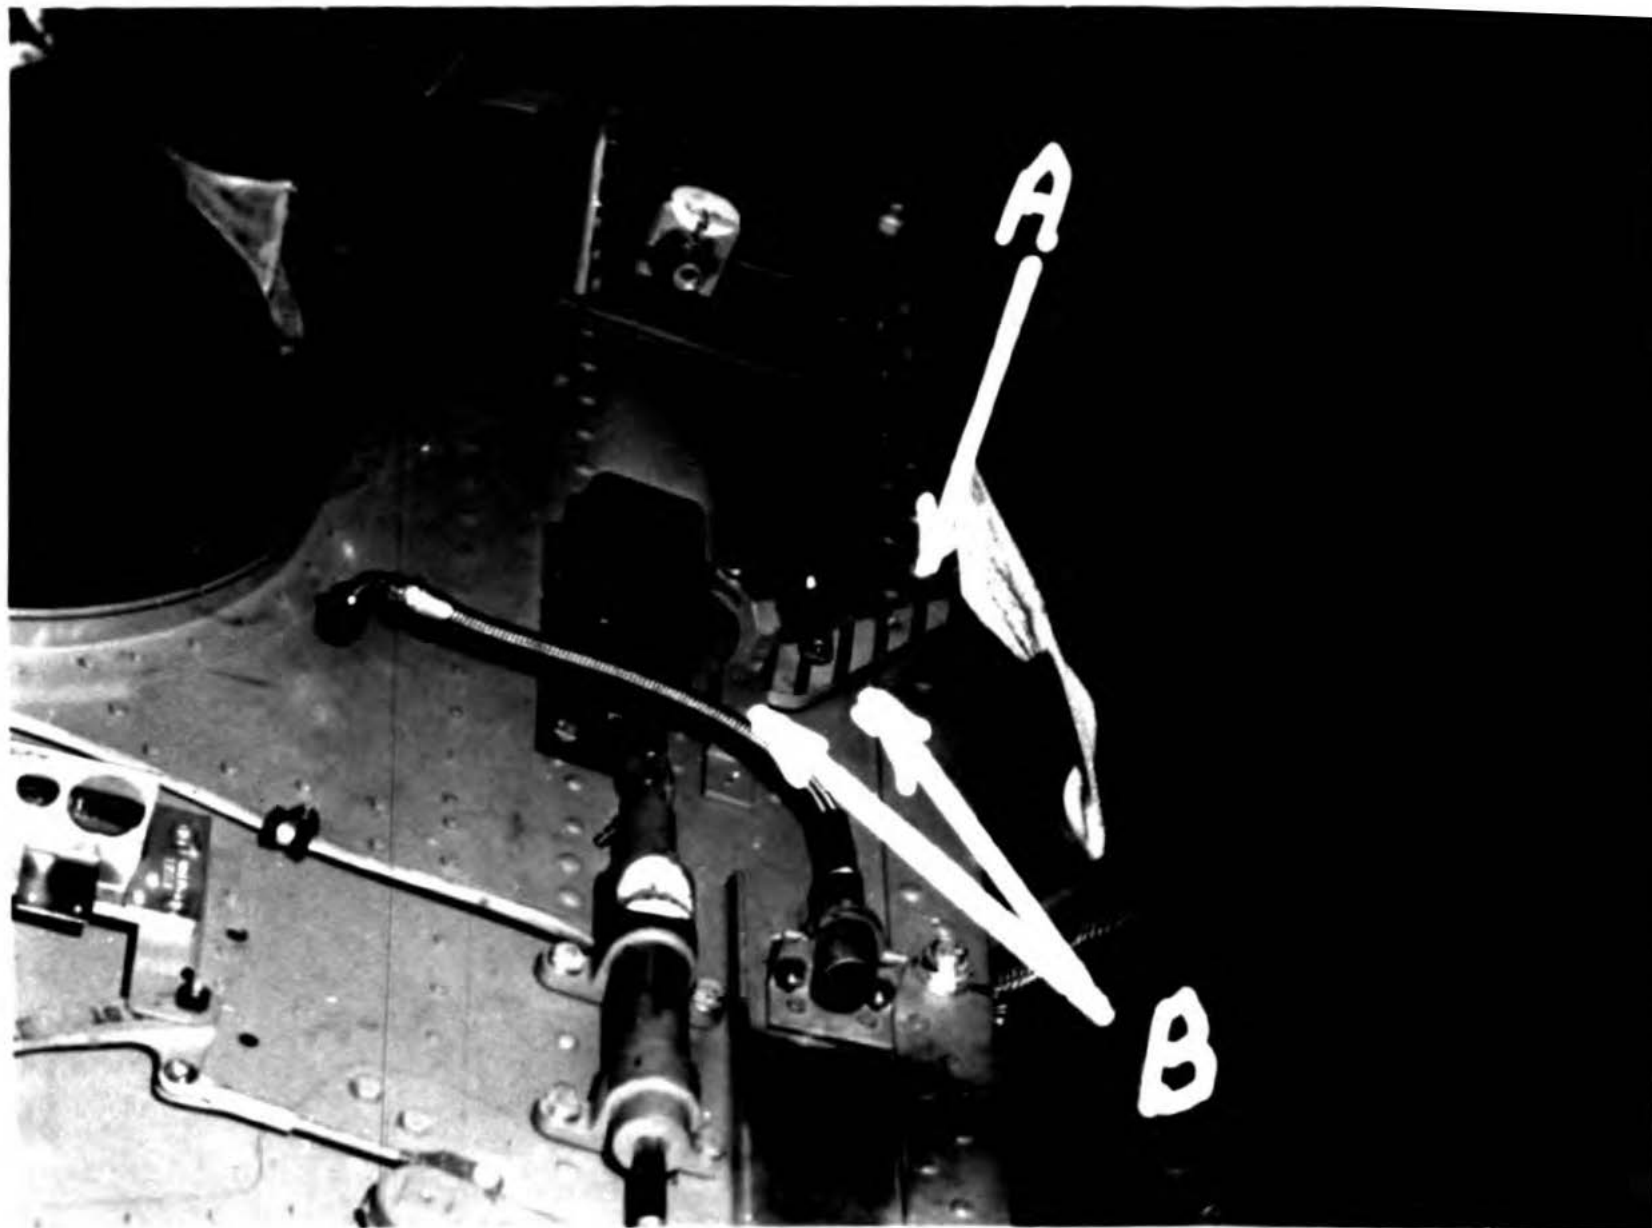
- b. The rear seat not separating from the pilot was due to the fact that the pivot pin in the striker bellcrank was missing at the time of ejection. There is evidence of wear in the striker bellcrank pivot pin hole indicating that the pivot pin had been installed at one time. Since there were no work orders issued requiring removal of this pivot pin, it is believed by the board, that this pin was not properly secured by a cotter pin at the time of installation or it was removed and reinstalled insecurely or not reinstalled at all without a work order being issued. All other seats of this squadron were inspected for missing pivot pins and all pivot pins were found in and properly secured. The maintenance inspection check sheet lists the aneroid area as a check item, but does not spell out the items in this area, one of which is the anchor pin for the striker bellcrank. ©

ENCLOSURE 61 THARON 7 AAR 6-61 T23-1 BMT 145222 PILOT: (b) (6) WHEN
 SHOWING THAT THE ARM PIVOT CLEVIS IS IN THE CORRECT POSITION. THE CLEVIS
 TO BE IN THE POSITION AS INDICATED BY ENCLOSURE 61. (A) BELIEVE AIR (B)
 WHERE PIN SHOULD BE. SPECIAL HANDLING REQ IRE. IN ACCORDANCE WITH NA A-
 00001 70 OPNAVINST.3750.6D.

2. It is recommended that both the intermediate and major check sheets on the maintenance of the ejection seats be revised so that the check sheet shows each item to be checked, especially the striker arm pivot pin, which is not listed on the check sheet. It is further recommended that no work be accomplished on the ejection system without a work order being issued.
